October Monthly Report for the Falls Creek Hydro-electric Project  
FERC # P-11659

**Falls Creek Hydroelectric Project (P-11659)**  
**MONTHLY CONSTRUCTION REPORT TO FERC**  
**October 2006**

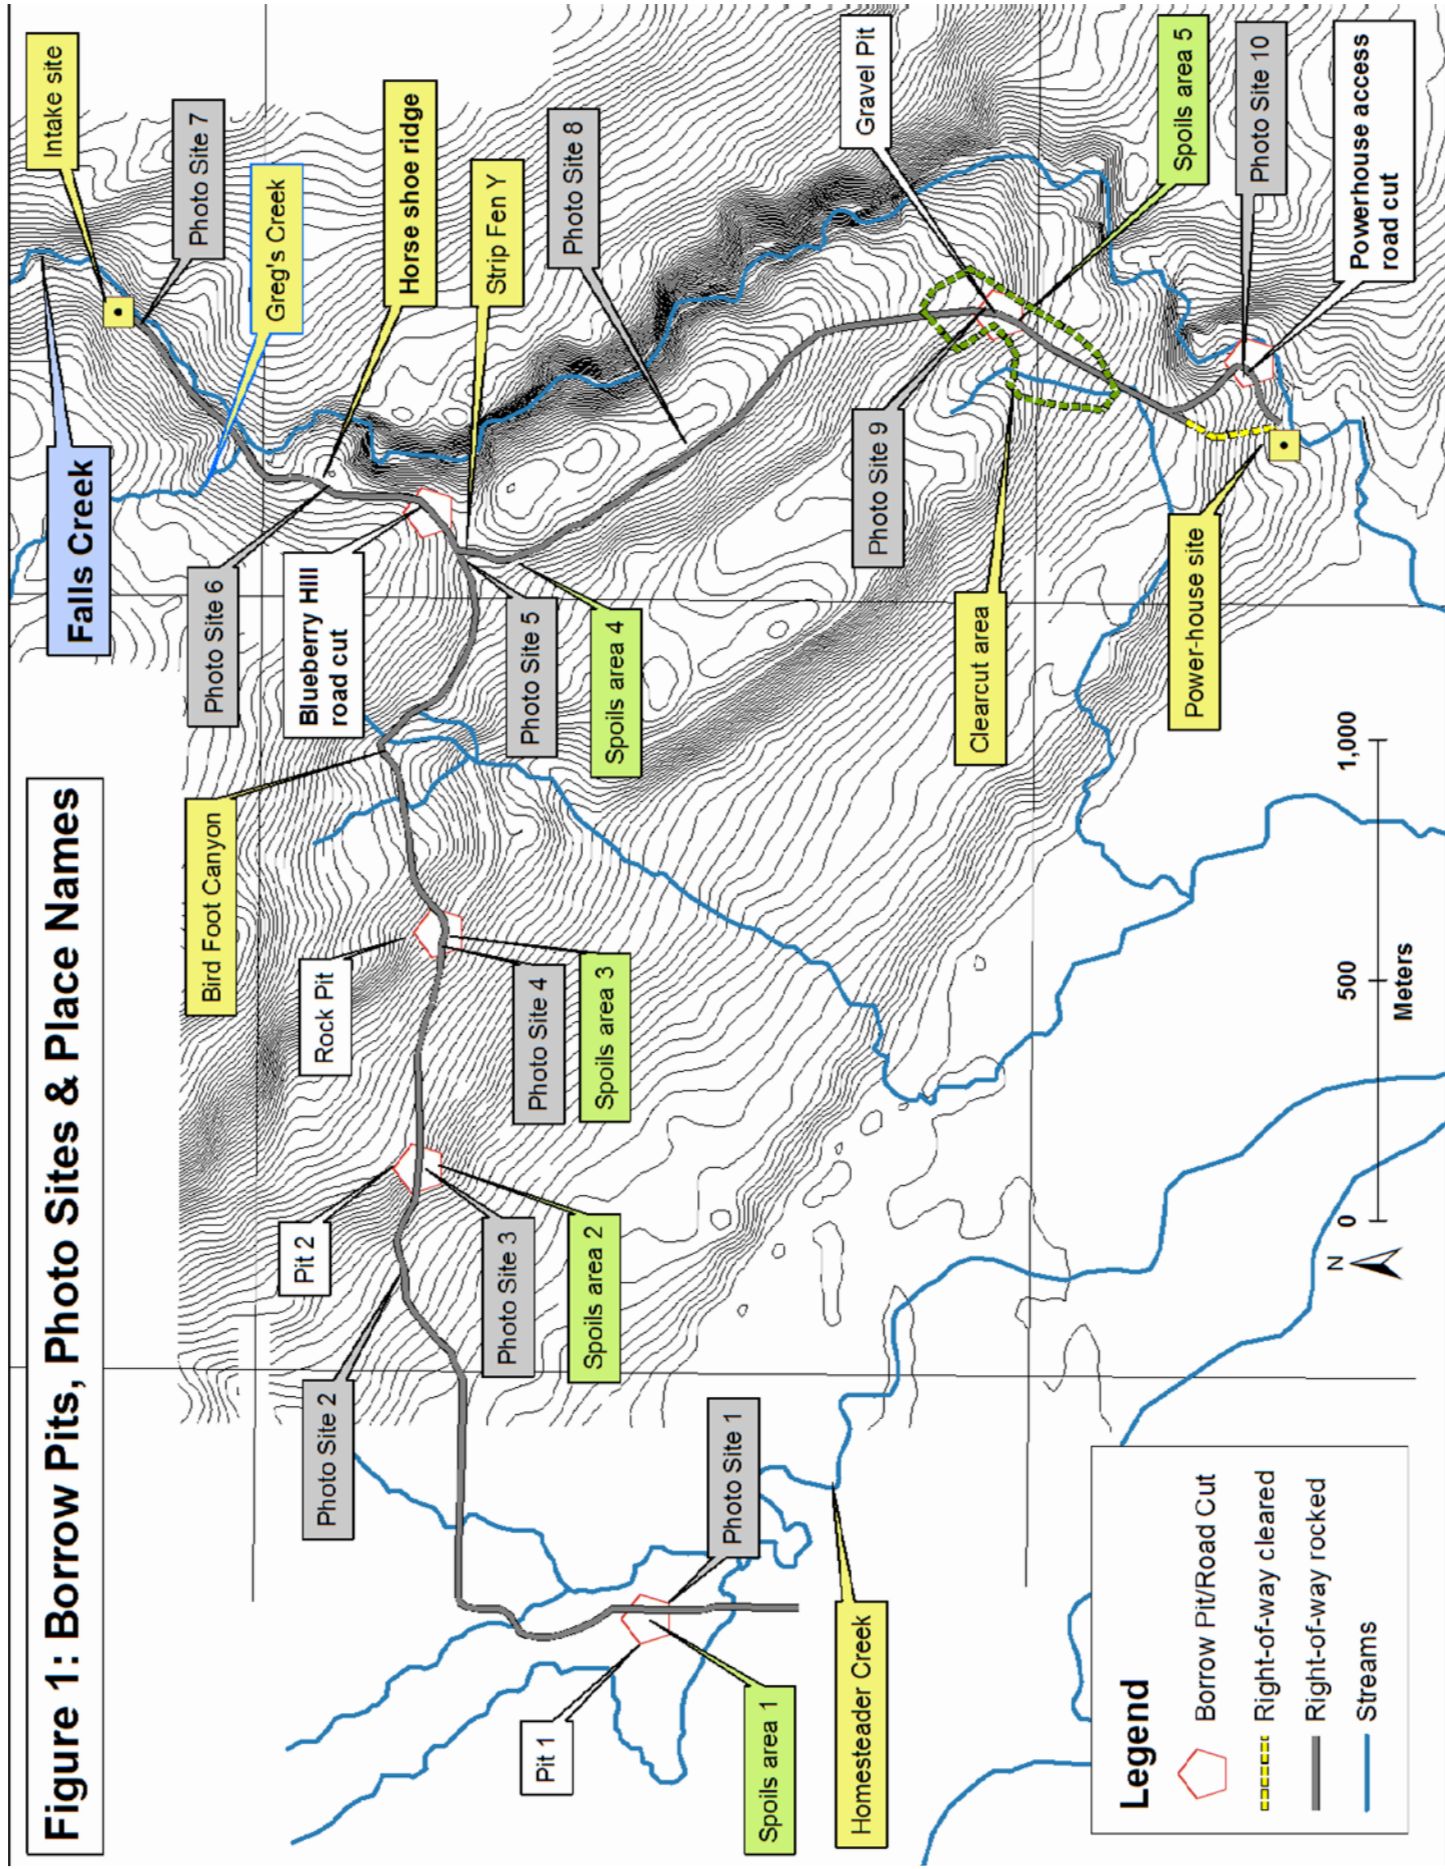
**Figure 1: Borrow Pits, Photo Sites & Place Names**

Ten photo vantage points have been established throughout the project area. See Figure 1 for photo site locations and Appendix 1 for this month's photos.
